# INDOOR AIR QUALITY ASSESSMENT

# Uxbridge High School 62 Capron Street Uxbridge, Massachusetts 01569

Prepared by:
Massachusetts Department of Public Health
Center for Environmental Health
Emergency Response/Indoor Air Quality Program
November 2005

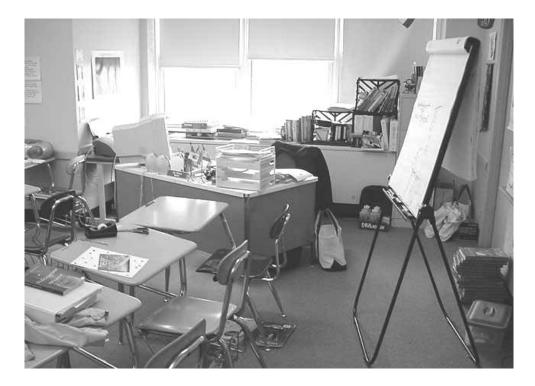
Fresh air in classrooms is supplied by a unit ventilator (univent) system. Univents draw air from outdoors through a fresh air intake located on the exterior walls of the building and return air through an air intake located at the base of each unit (Figure 1). Fresh air and return air are mixed, filtered, heated and provided to classrooms through an air diffuser located in the top of the unit. Univents were found deactivated in some classrooms. Obstructions to airflow, such as objects stored on or in front of univents, were also observed in a number of classrooms (Picture 1). In order for univents to function as designed, univents must be activated and remain free of obstructions.

**Univent behind Desk**

- 7. Remove all blockages from univents and exhaust vents to ensure adequate airflow. Shut classroom doors to facilitate air exchange.
- 8. Change filters for air handling equipment as per the manufacture's recommendations or more frequently if needed. Clean out interiors of univents regularly (e.g., during scheduled filter changes).

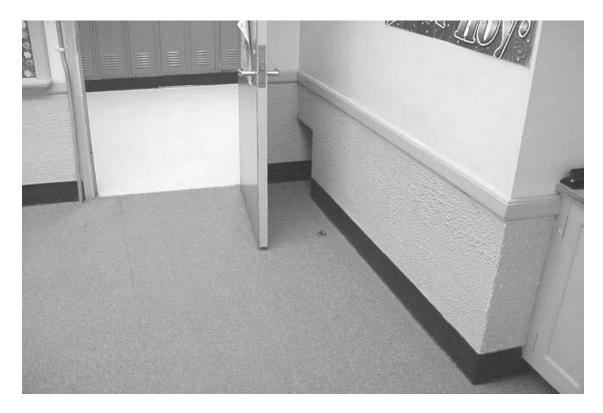
The mechanical exhaust ventilation system consists of wall-mounted exhaust vents, some of which are located in ungrated holes at floor level (Picture 2). These vents are connected to exhaust fans on the roof. Filing cabinets and other items obstructed a number of exhaust vents.

**Example of Exhaust Vent, Note its Location behind Hallway Door**

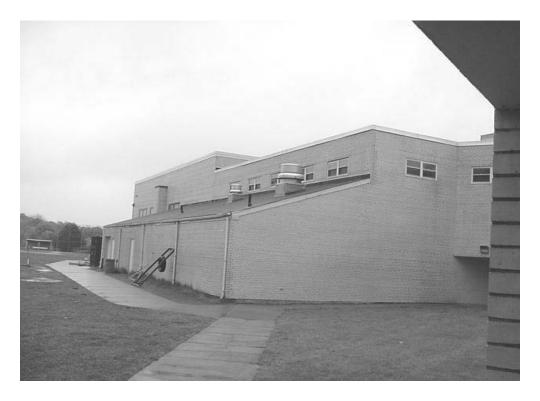
A number of interior areas of the building had signs of water damage in ceiling tiles. While some classrooms appear to have experienced leaks through window frames, the library had a large number of water damaged ceiling tiles. As reported by Michael Legenedre, Uxbridge Schools Plant Manager, flashing is missing between the roof and exterior wall of the library (Pictures 3 and 3A). This condition has led to both wind-driven rain and snow to penetrate under certain wind conditions. The integrity of the building envelope (e.g., roof, exterior walls, foundation, window and doorframes) must

**Exterior View of Roof/Exterior Wall Joint of Library**

- 1. Examine the feasibility of reestablishing the integrity of the building envelope by installing flashing for the library roof.
- 2. Examine the feasibility of providing local exhaust vents for the printing press. If not feasible move the printing press to an area with an exterior wall where exhaust ventilation can be readily installed or already exists.

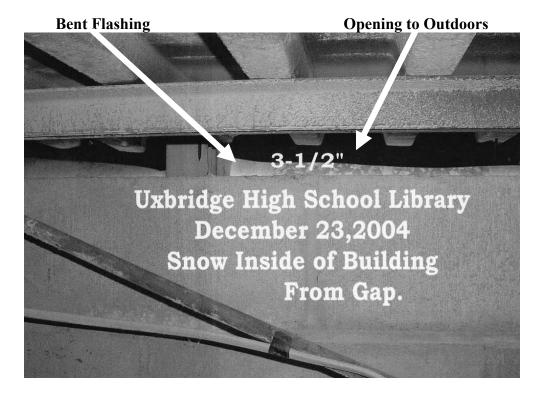
Interior View of Space between Wall and Roof Decking (Photo Taken By Michael Legendre, Uxbridge Public Schools)

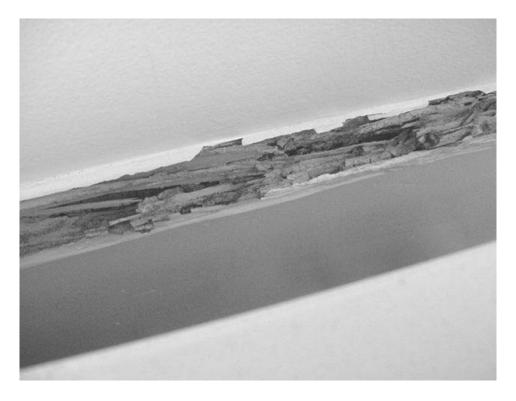
Of note was termite damage and water damage to windowsills and wood molding located in the basement of the original building (Picture 4). Wood boring insects tend to attack soft, moist wood. The termite infestation is a sign that water is likely penetrating through the foundation. Shrubbery was observed growing in close proximity to the foundation (Pictures 5 and 6). Roots growing against the exterior walls can bring moisture in contact with walls and eventually lead to cracks and/or fissures in the foundation below ground level. Over time, this process can undermine the integrity of the building envelope and provide a means of water entry into the building through capillary action through foundation concrete and masonry (Lstiburek & Brennan, 2001).

**Termite Damage to Wood in Basement Classrooms**

- 12. Consider the following actions to prevent moisture penetration into the basement/crawlspace:
  - a) Remove foliage to no less than five feet from the foundation.

- b) Improve the grading of the ground away from the foundation at a rate of 6 inches per every 10 feet (Lstiburek & Brennan, 2001).
  - c) Install a water impermeable layer on ground surface (clay cap) to prevent water saturation of ground near foundation (Lstiburek & Brennan, 2001).

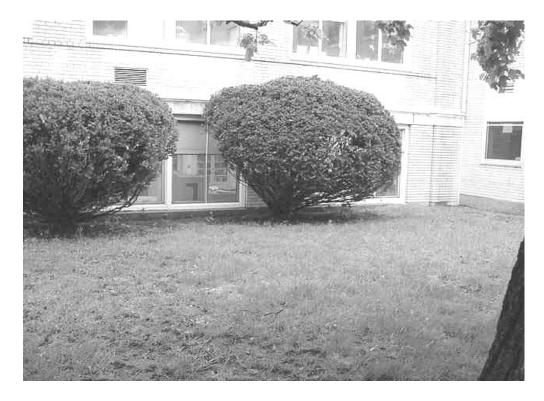
**Shrubbery outside Classrooms with Termite Damage**

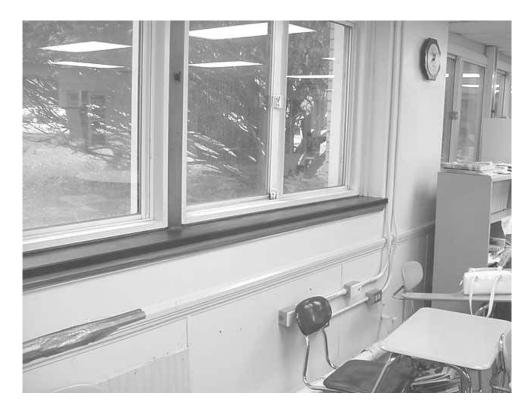
View of Shrubbery from Inside Classroom with Termite Damage

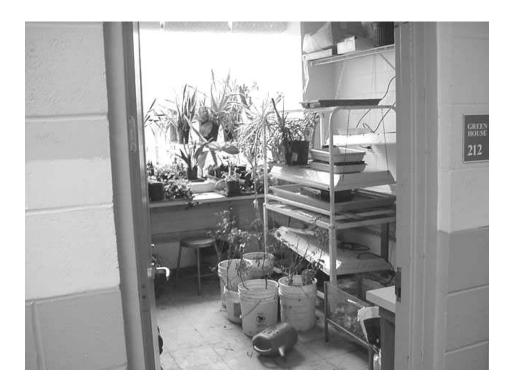
The science wing contains a greenhouse (Pictures 7 and 8). The greenhouse does not have a local exhaust fan to vent water vapor, excess heat, particles and odors associated with horticulture out of the building. Without an exhaust vent, particulates and odors from the greenhouse can migrate into adjacent areas via the hallway door.

View of Greenhouse from Hallway

- 3. Replace water damaged ceiling tiles.
- 4. Consider installing an exhaust fan in the window of the greenhouse.
- 5. Examine each univent for function. Survey classrooms for univent function to ascertain if an adequate air supply exists for each room. Consider consulting a heating, ventilation and air conditioning (HVAC) engineer concerning the calibration of univent fresh air control dampers school-wide.

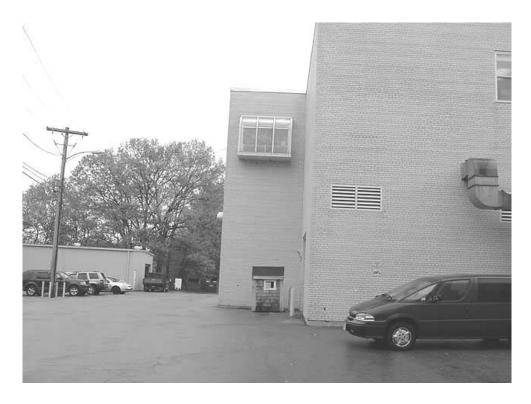
**Exterior View of Greenhouse**

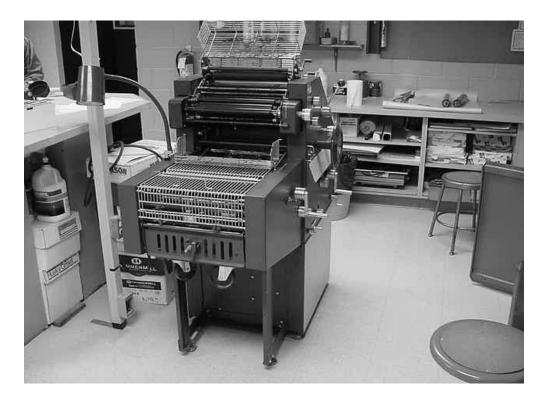
Several other conditions were noted during the assessment that can affect indoor air quality. Room 007 contains a wet ink printing press (Picture 9). No local exhaust ventilation exists for the printer. Inks, washes and hand cleaners used in printing can

contain volatile organic compounds (VOCs), which can be irritating to the eyes, nose, throat and respiratory system. Products containing VOCs should be used with adequate exhaust ventilation to prevent exposure.

**Wet Ink Printing Press**
